NRL Memorandum Report 4418

Sonar Transducer Reliability Improvement Program (STRIP), FY 81 First Quarter Progress Report

Underwater Sound Reference Detachment P.O. Box 8337 Orlando, Florida 32856

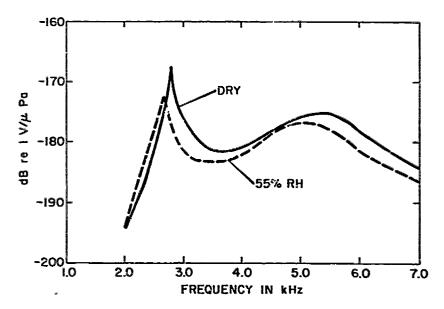
Acoustic measurements are being made on the modified TR-208 transducers as a function of internal RH. Data shown in Fig. 11.1 for the open-circuit free-field voltage sensitivity for the same transducer when dry and at 55% RH. The effects of the water vapor are marked. However, repeatability with other transducers has not been good. Improvements in the statistics are expected in the next phase with the use of DT-308 hydrophones as test vehicles. Modification is in progress on the DT-308 test fixtures to be used in the next phase of this work. Almost all of the switches and associated hardware has been received for wiring the elements of these transducers for independent testing.

Fig. 11.1 - Open-circuit free-field voltage sensitivity of a modified TR-208 with two different water vapor contents.

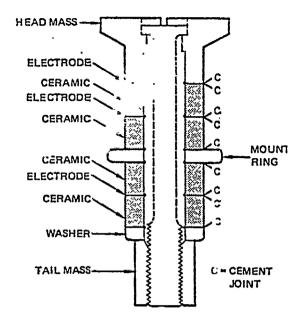
Fig. 12.3 - Makeup of a typical K_{33} ceramic resonator

A cutaway section of a typical TR-316 resonator illustrated in Fig. 12.3 shows the use of cement to provide strength and coupling of the ceramic rings to the electrodes, head, tail washer, mount ring, and to each other. As the cement heats up it becomes more compliant and less effective in providing strength and coupling to the ceramic stack. One solution to this problem is to increase the pre-stress on the ceramic stack while curing the cement; thus forcing more of the cement out of the joints and increasing the coupling. However, this solution may not be feasible with all ceramic stacks.

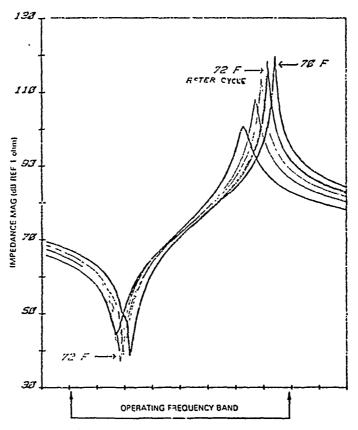
When measuring the impedance of TR-316 resonators as a function of temperature for the very first time, it has been observed that after the resonator has returned to room temperature the anti-resonance peak has shifted down in frequency as illustrated in Fig. 12.4. This has occurred with almost all of the resonators tested. This seems to indicate that some "settling" has occurred within the ceramic stack. Possibly the cement experiences additional curing during the first temperature cycle. Subsequent measurements of the "in air" impedance at room temperature cycles. The resonance peak has not been as predictable; sometimes shifting down on one resonator, up on another, and perhaps not moving at all on still another.

Fig. 12.4 - Impedance magnitude vs frequency

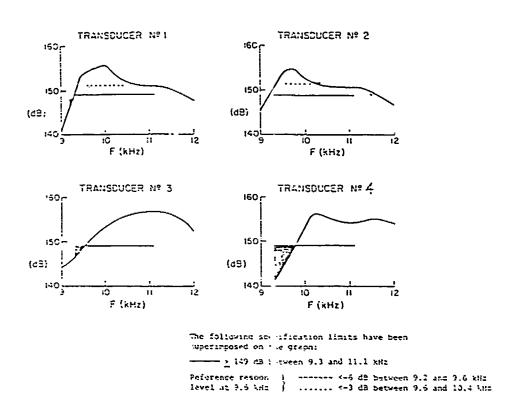
Transmitting Voltage Response (TVR) measurements on the transducers filled with Baker dB-grade castor oil are plotted in Fig. 14.1. A stiffening effect, noted in the response of each transducer, resulted in an upward shift of the resonance frequency of 400 to 800 Hz. This shift causes the specified cardinal points to move out of the acceptable range. An example of the devastating effects of this can be seen in the graph of Fig. 14.1, which shows that all of the transducers fail to meet one or more of the specifications.

Fig. 14.1 - TVR measurements on TR-122 transducers filled with Baker dB-grade castor oil

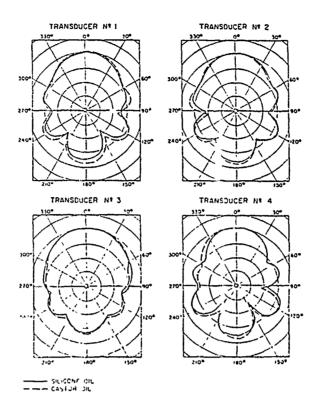
Directional Response (DR): Directional response measurements were made in the XY plane at 9.6 kHz. A comparison of these measurements is shown in Fig. 14.5. Table 14.2 lists the DR measurements and the specification. There seems to be no problem in meeting the requirements.

Fig. 14.5 - TR-122A/B (BQC-1) transducer - a comparison of dimethyl silicone of with castor oil in the XY plane at 9.6 kH.:

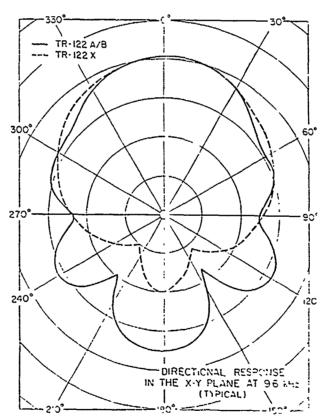
Fig. 14.9 - Directional Response in the XY Plane at 9.6 kHz (typical). Note the reduction of back lobes in the TR-122X.
